Accelerometer Crash Test Investigation Performed on 2 May 2011

Document Created On: 2 June 2011

Executive Summary

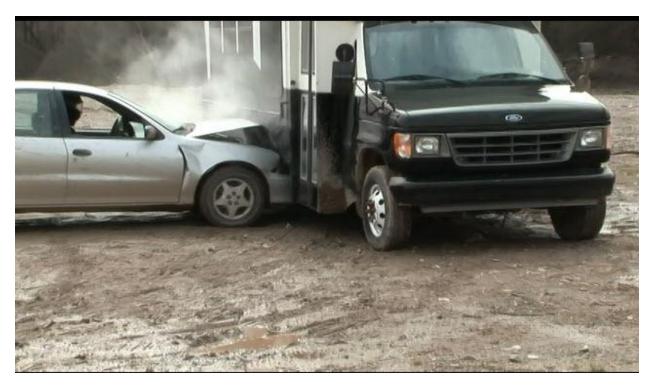
Figure 1: Vehicle driven into the side of the bus at 20km/h

- 1) Vehicle driven into the back of the bus at 5km/h
- 2) Vehicle driven into a concrete median at 5km/h
- 3) Vehicle driven into the side of the bus at 20km/h
- 4) Vehicle driven into the wheel of the bus at 20km/h
- 5) Vehicle driven into the back of the bus at 20km/h
- 6) Vehicle driven into a concrete median at 20km/h

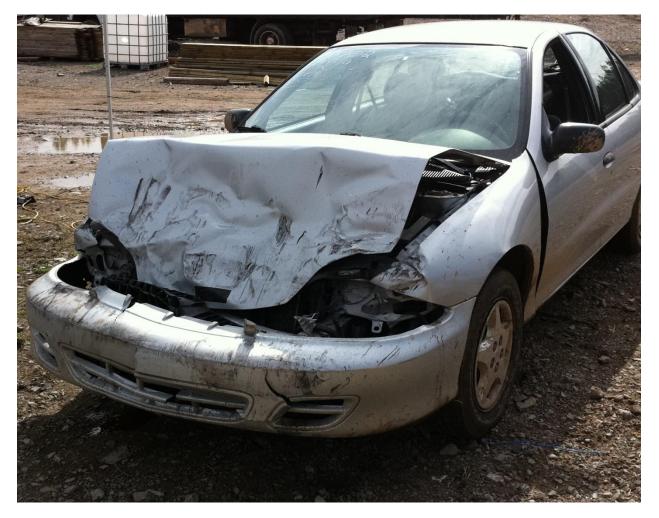
Figure 2: The front of the vehicle after a full days testing
